# Safety Inspection Report

Annual Inspection

## Playground, Llechryd

24 March 2025

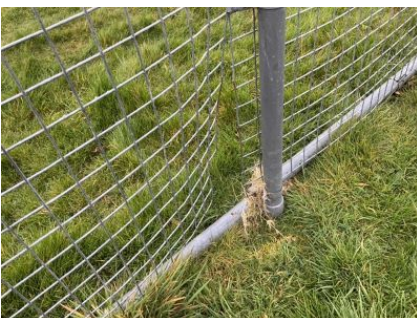
Minor repairs are needed.

## Repair.

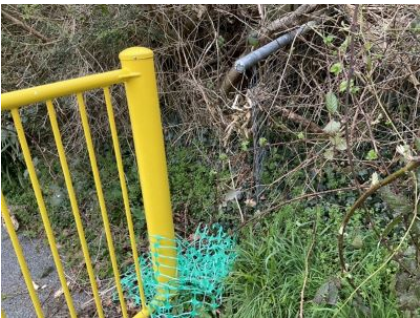
A section of the fence is missing.

Replace the missing parts.

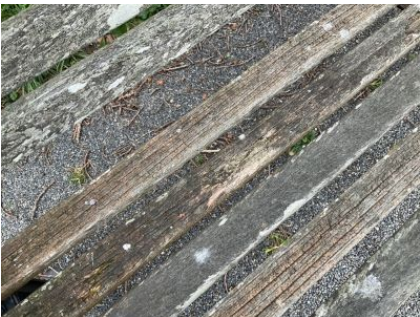
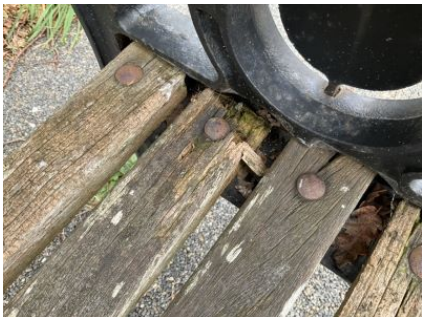
Timber is decayed.

Replace affected parts.

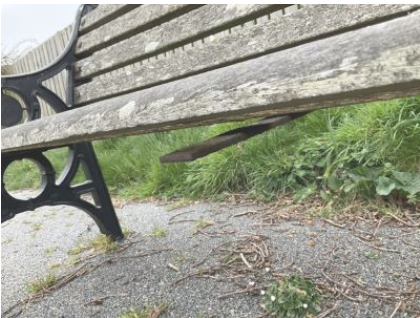
Fixtures loose or missing.

Replace.

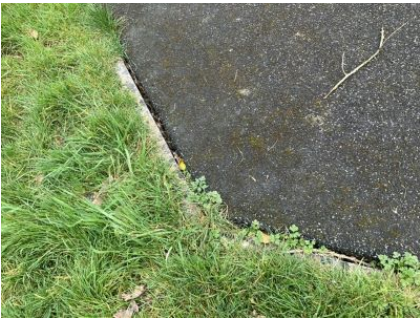
Shrinkage / separation of the surface. This may give a trip hazard.

Repair.

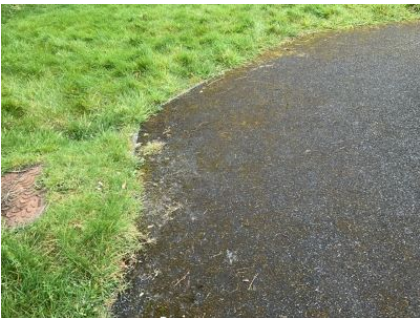
Moss is present.

Remove.

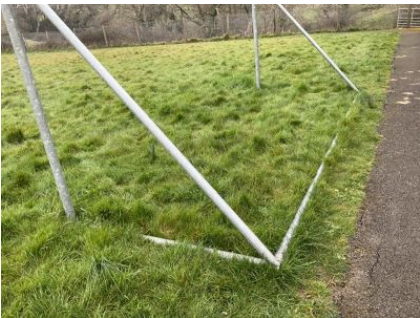
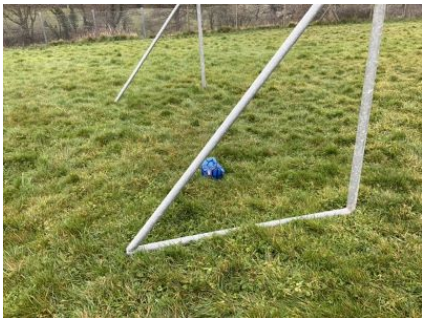
Additional comments are noted below.

Secure to ground.

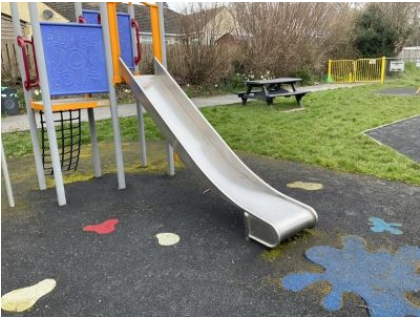
Slide chute faces south east and may become very hot in sunny weather. Provide warning signage.

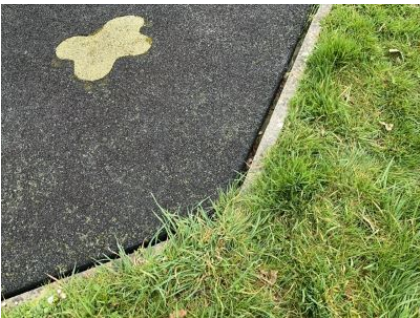
Shrinkage / separation of the surface. This may give a trip hazard.

Repair.

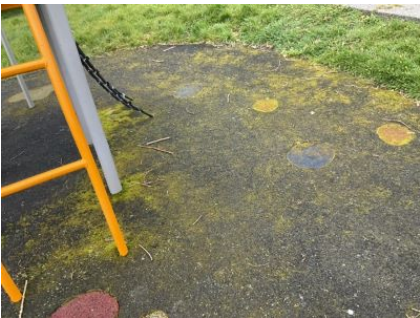
Moss is present.

Remove.

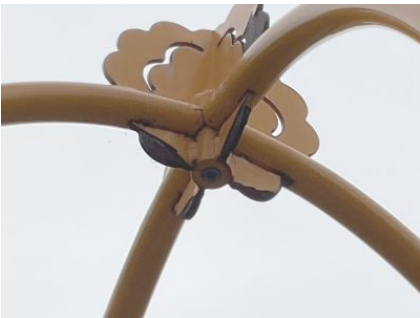
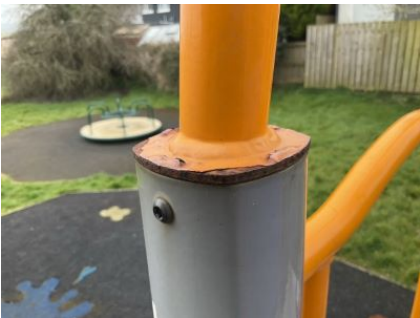
Item has corrosion.

Treat and repair.

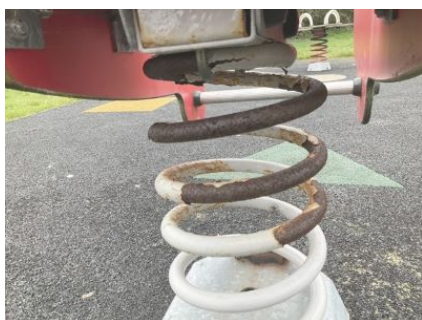
Item has corrosion.

Treat and repair.

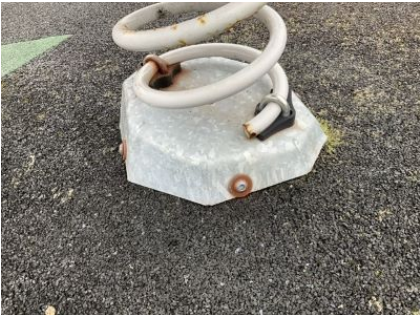
Fixtures loose or missing.

Base plate.

Tighten/replace.

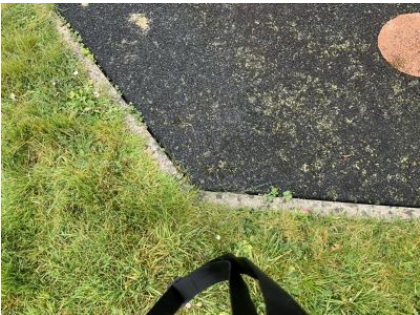
Shrinkage / separation of the surface. This may give a trip hazard.

Monitor.

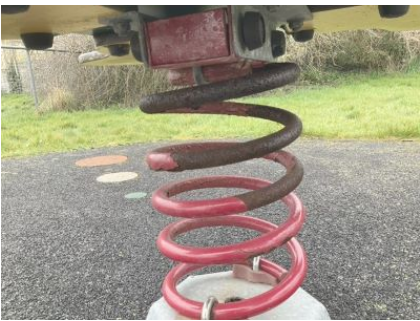
Item has corrosion.

Treat and repair.

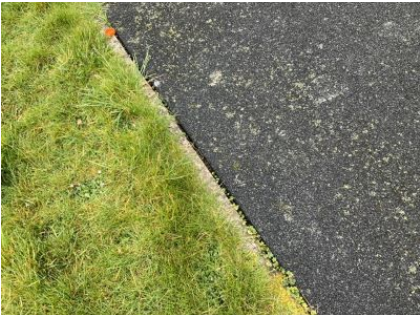
Shrinkage / separation of the surface. This may give a trip hazard.

Monitor.

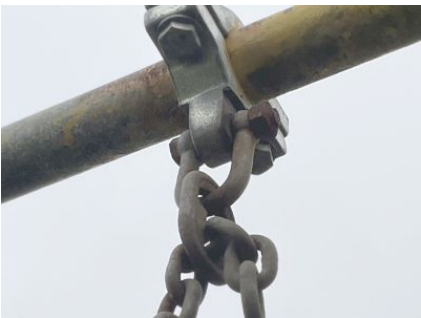
There is wear in the bushes.

Remove shackle bolt and check bush and shackle pin wear, replacing as necessary.

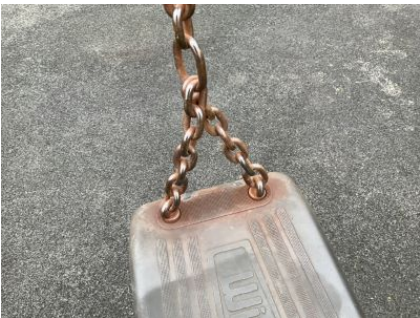
Some chain wear.

Monitor for further deterioration and replace before 40% wear.

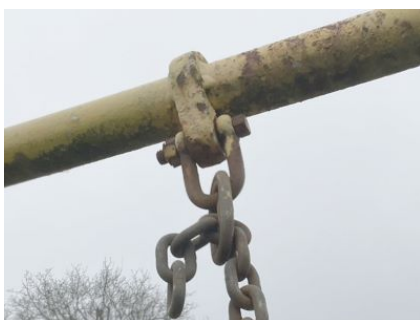
There is wear in the bushes.

Remove shackle bolt and check bush and shackle pin wear, replacing as necessary.

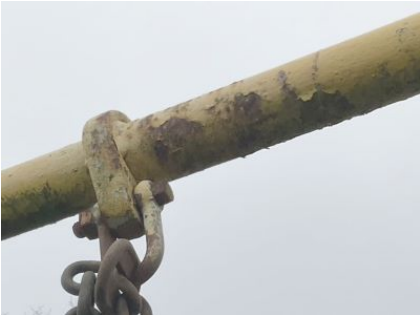
Item has corrosion.

Treat and repair.

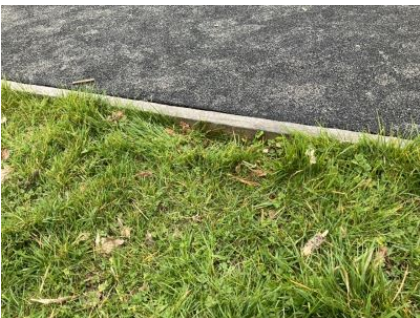
Trip points on the surface.

Make level.

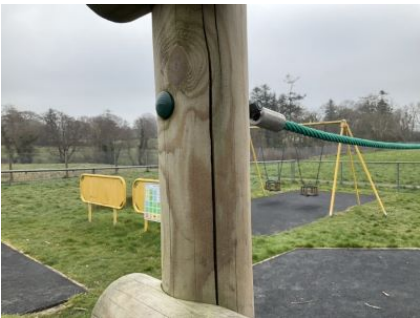
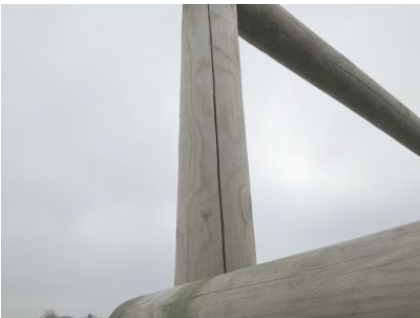
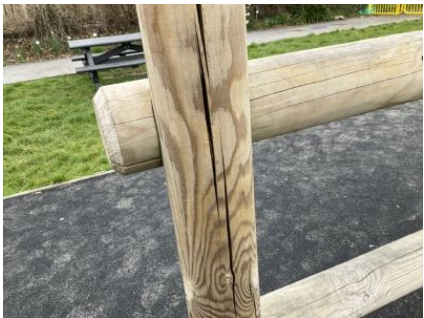
There are natural splits / shakes in the timbers.

Monitor and sand back any splintered edges as required.

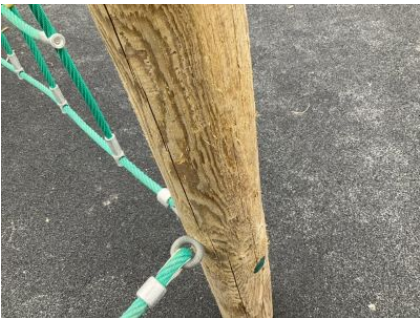
There are splinters or the potential for splinters.

Sand the timber down to remove the splinters and/or the places liable to give splinters.

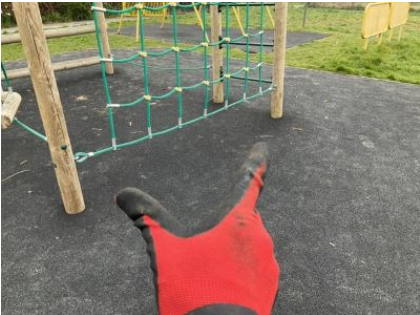
Loose in ground.

Slight movement. Monitor.
