## **Llangoedmor Community Council review of walk along A484 – Croes Y Llan, Llangoedmor to Glanarberth, Llechryd**

**Following the Council's meeting on the 6.11.17 the Council request that the provision of footways be considered for the 40mph to 30mph limit (Cardigan to Llechryd) and the 30mph sign to Glannant.**

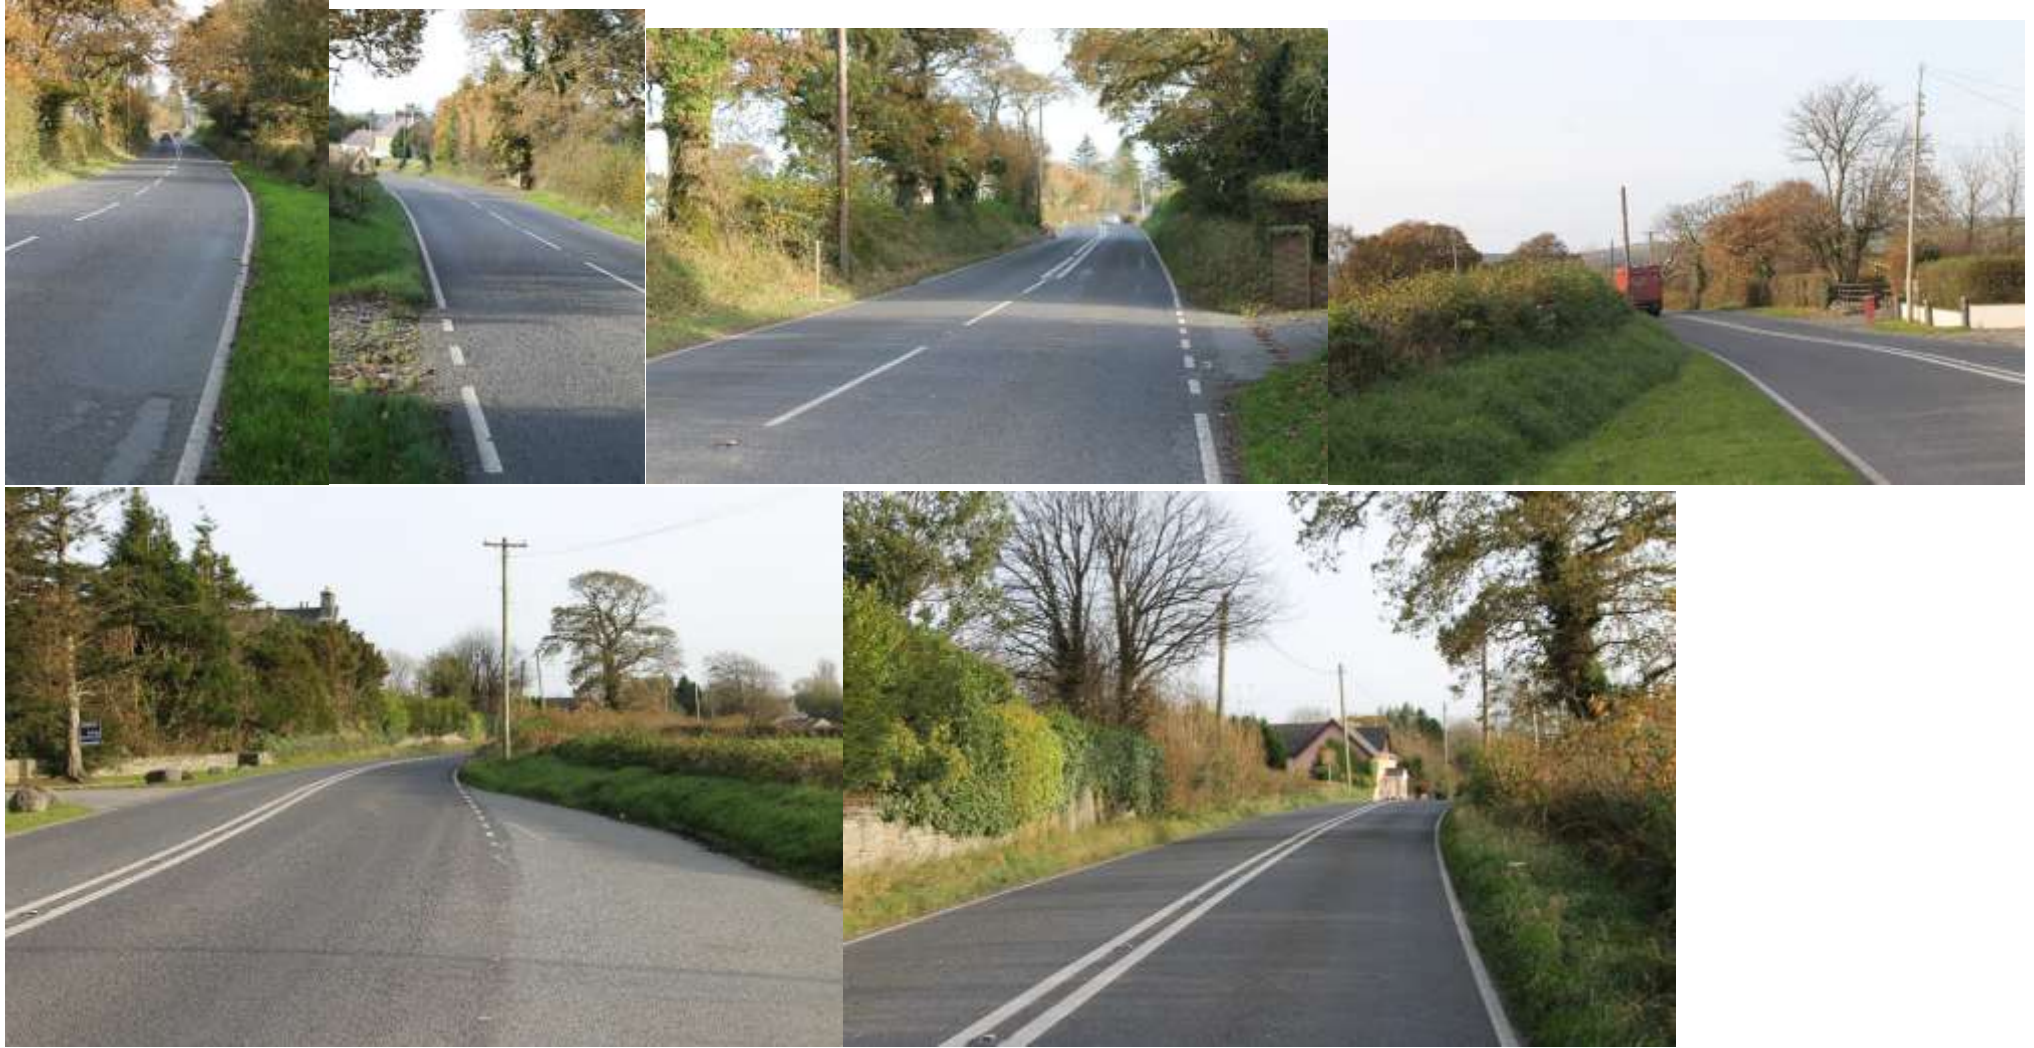
Photographs taken between Croes Y Llan crossroads on the A484, walking towards Llechryd prior to the 40mph limit. Illustrates the poor visibility

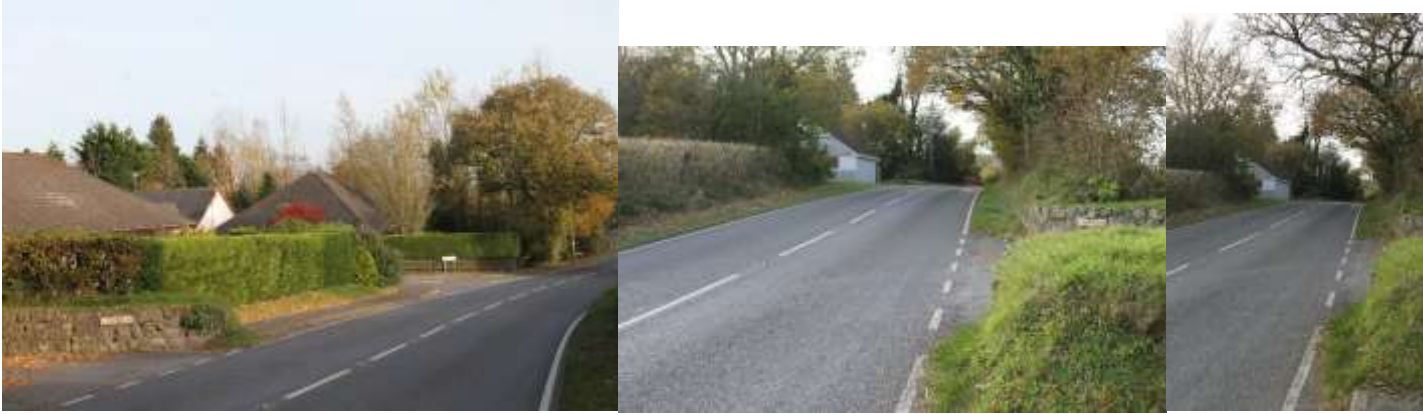
From 40mph sign towards entrance to Waungiach

Above: Junction to Waungiach turning towards Cardigan very poor visibility for vehicles. Pedestrians stepping out onto road blind at the end of the footway.

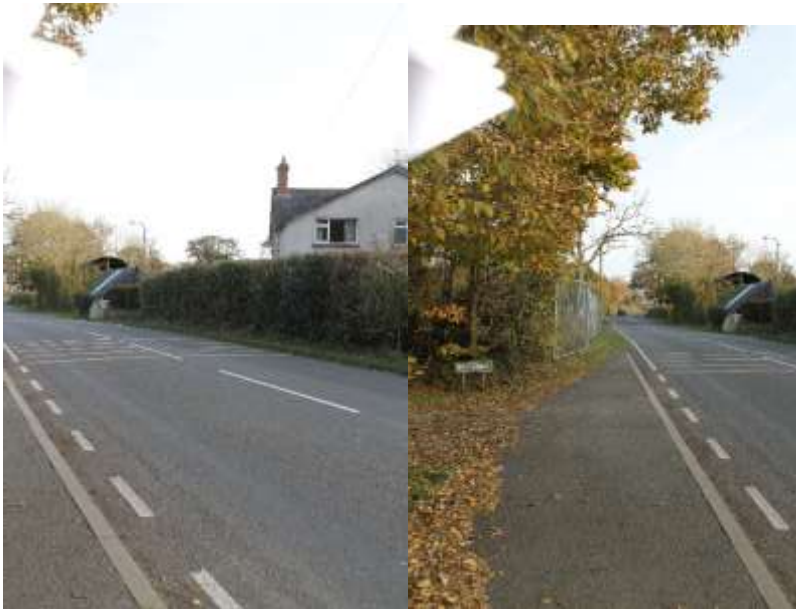
Below: Road adjacent Brynsiriol: Pinch point, not footway on either side of the road. Could be improved if verges and hedges better maintained throughout the year. Is provision of footway part of planning for plots? Heras fencing seems to be highways side of plot boundary forcing pedestrians into road.

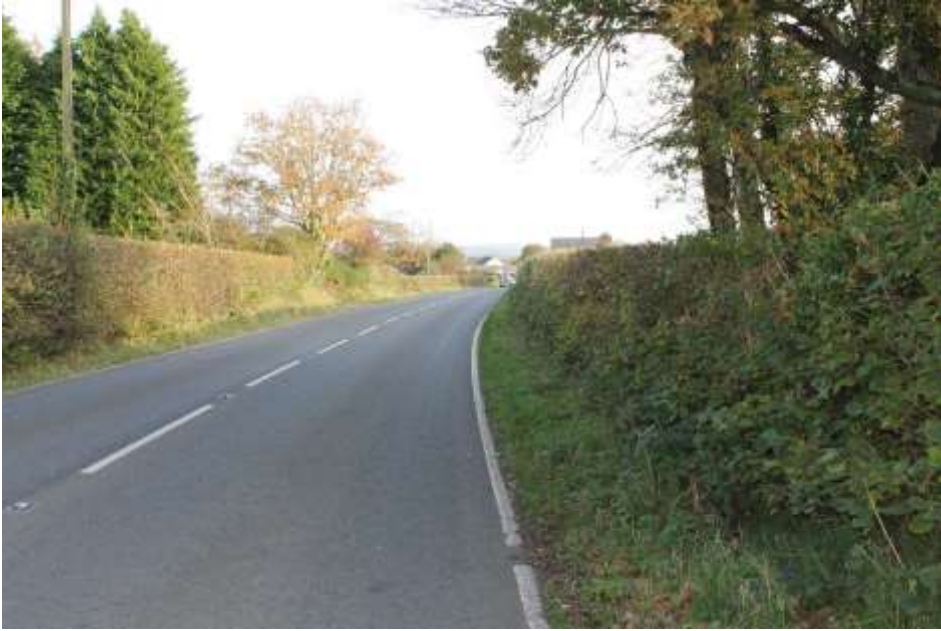
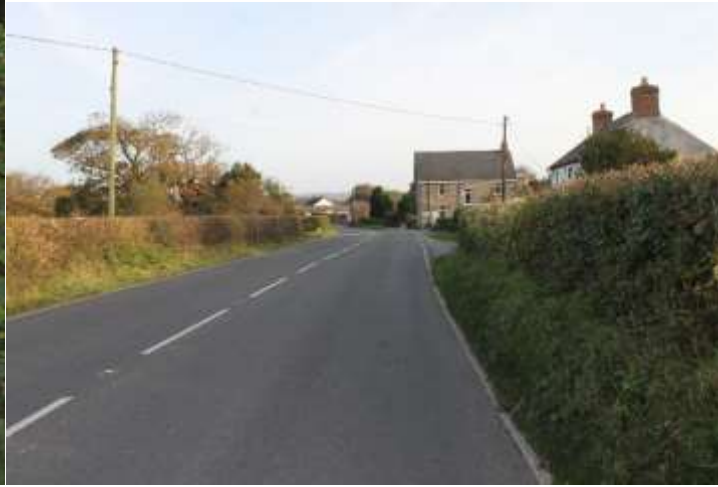
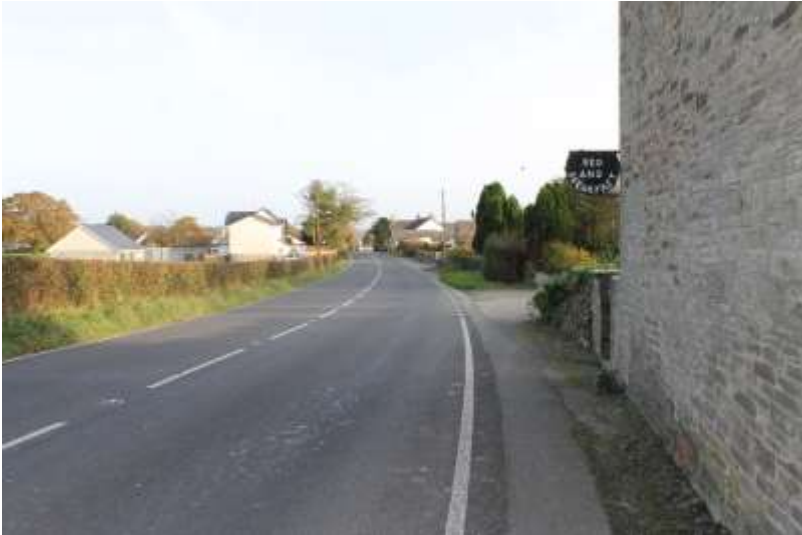
Moving from area adjacent Brynsiriol towards 30mph limit sign no footways on either side of the road. Limited verge space and during summer visit the hedgerows were so overgrown it was impossible to use what little verge there was.

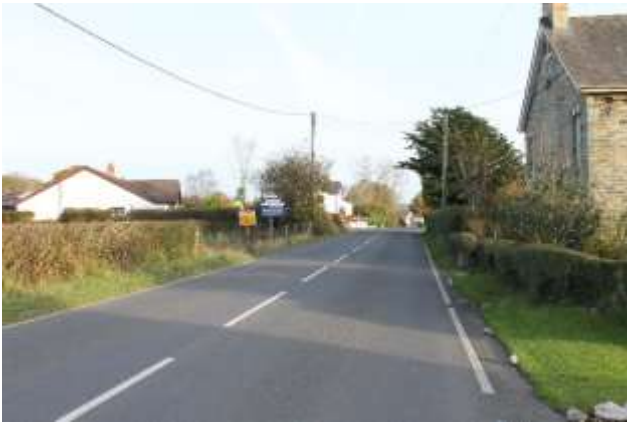
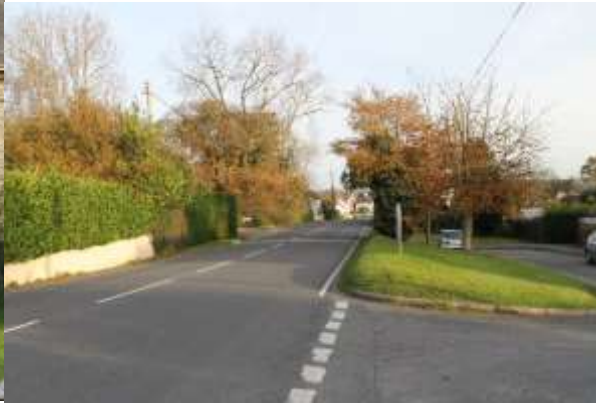
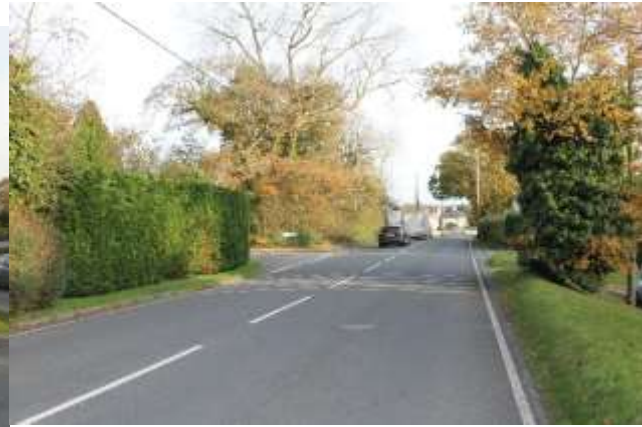
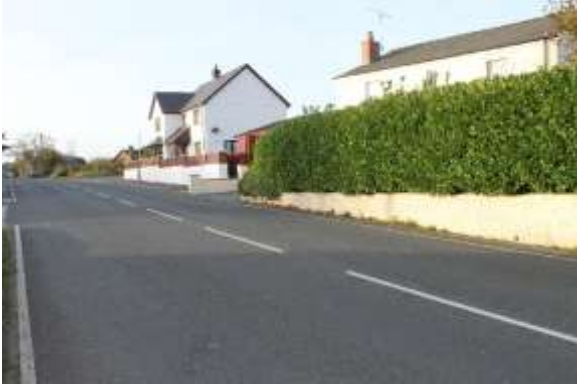
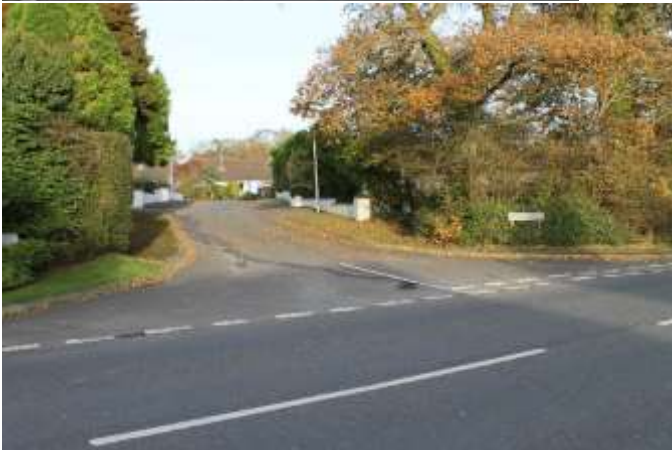
From 30mph sign consistently no footway and areas of poor vision for traffic and pedestrians. Junction with Brynbedw offers very poor visibility for drivers in both directions. No footway adding to the issues for both pedestrians and drivers.

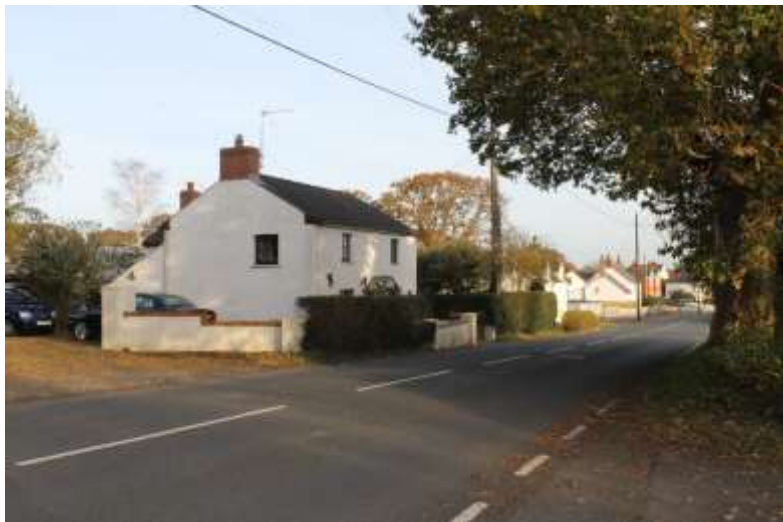
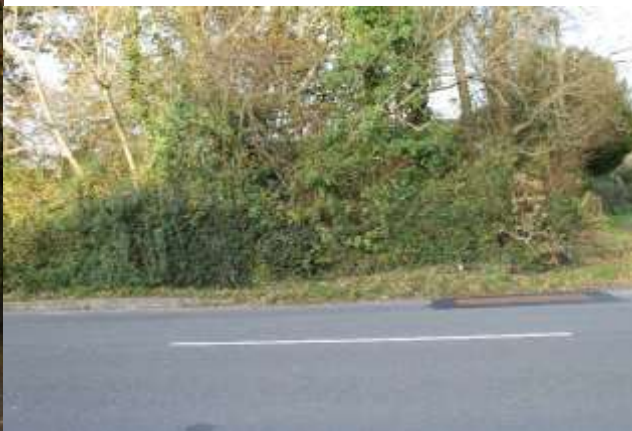
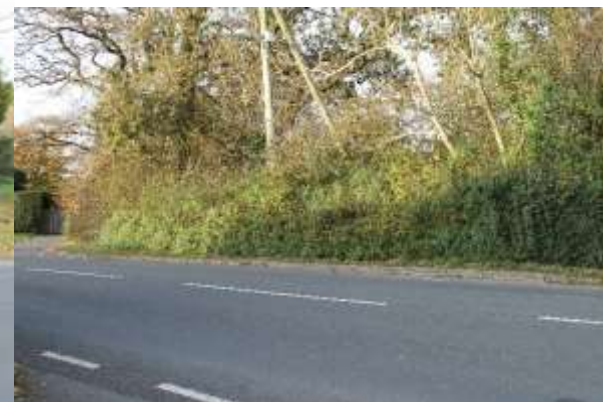
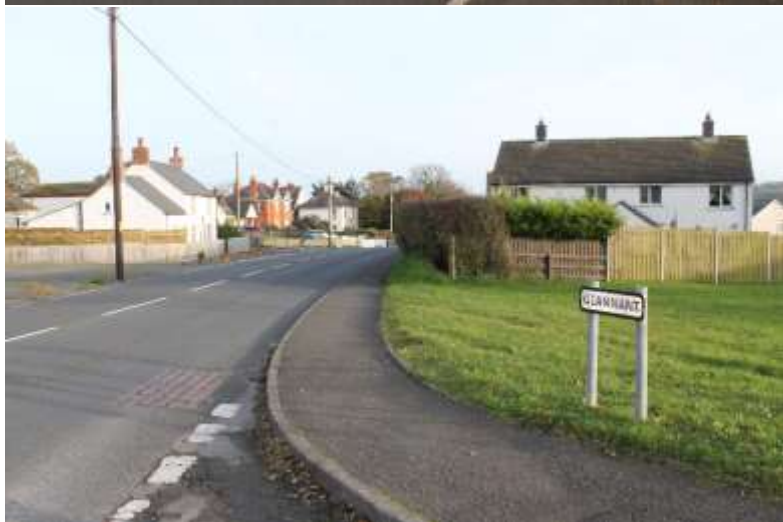
Continuing into the village here is no footway or continuous consistent verge area until reaching Glannant. From Glannant to just above the 7 Stars there is an adequate footway. It is in need to attention in places due to tarmac surface dipping and cracking and grass creeping over kerbstones from adjacent land narrowing the width.

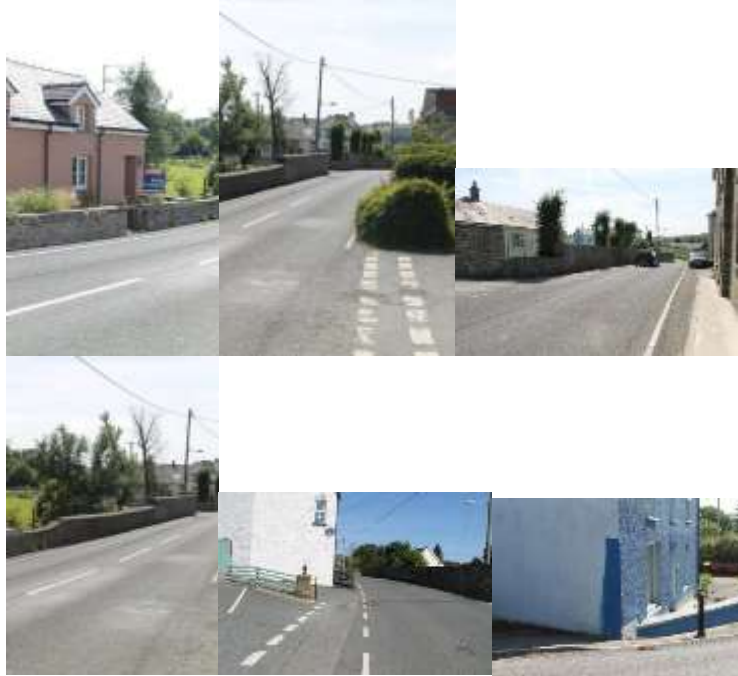
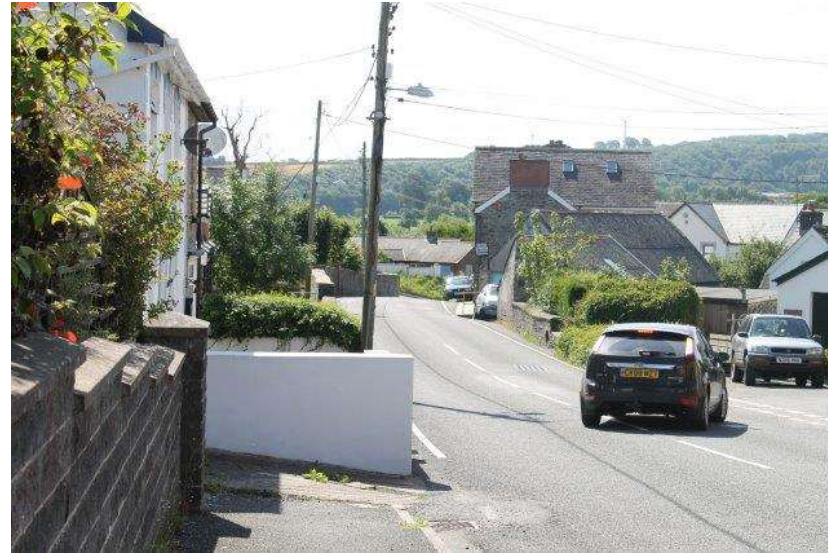
Area between 7 Stars and Flambards

Footway ends leaving a very dangerous walk over the bridge and beyond

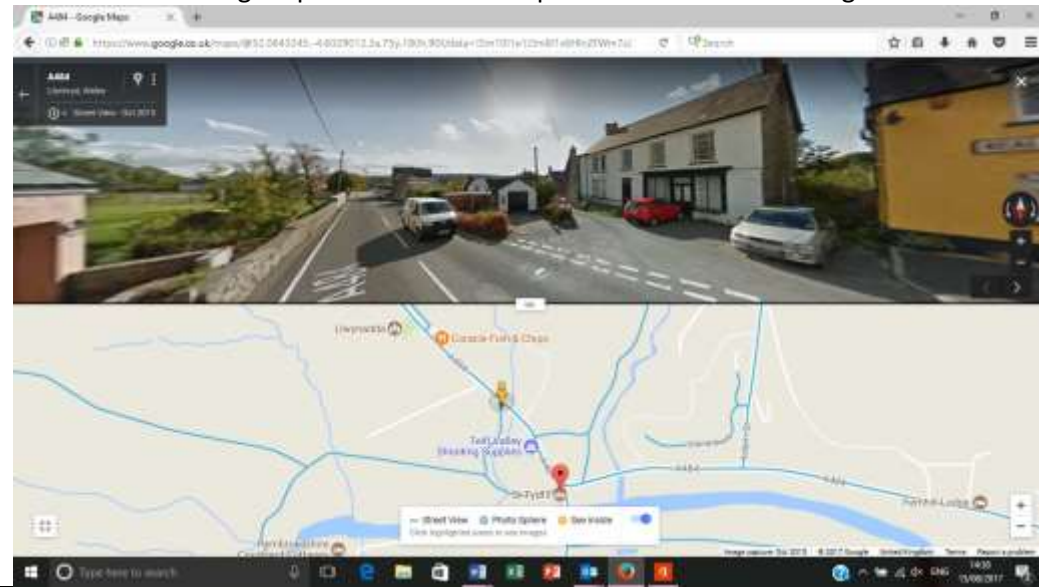
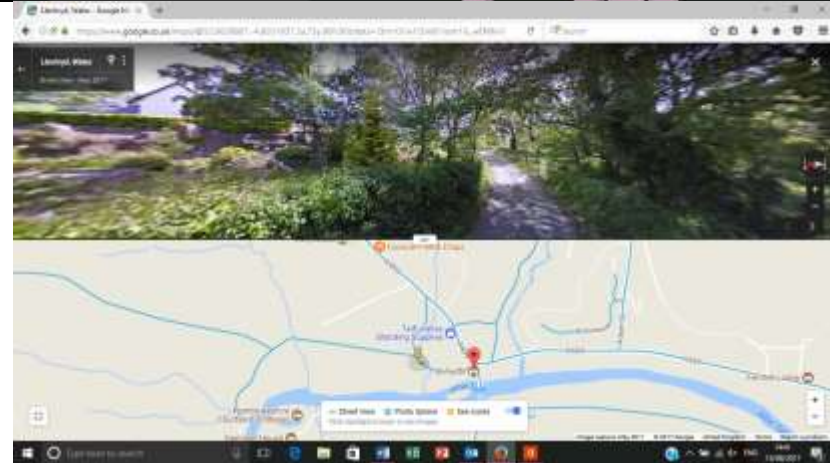
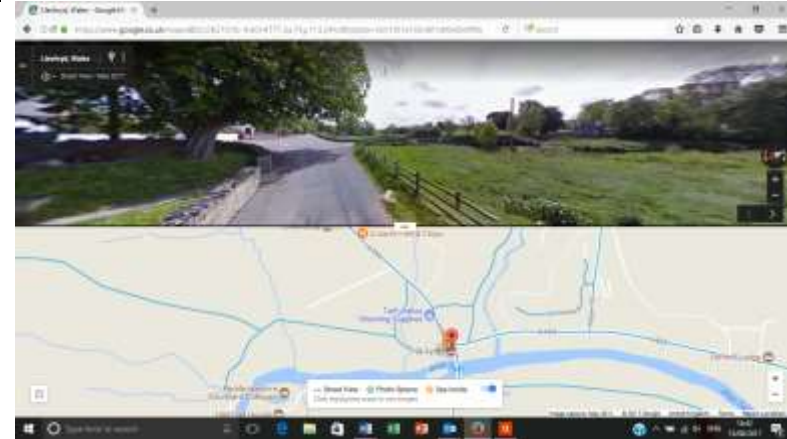
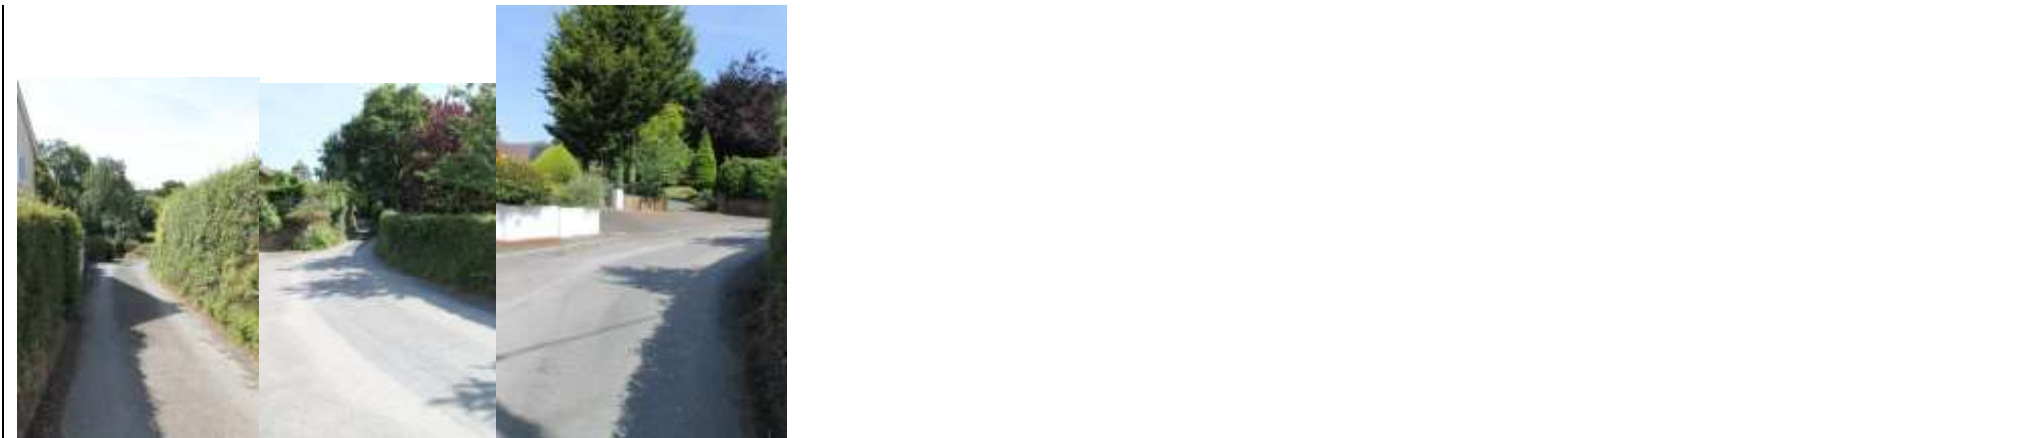
Potential to investigate possible alternative pedestrian route – although much of route is steeper and single track in places safer shared space?

**Further the Community Council requests that Ceredigion County Council investigate the highlighted proposed alternative route from the 7 Stars to Llechryd bridge with the aim of encouraging pedestrians to use this route rather than cross the bridge on the A484 by the 7 Stars. The suggestion is that the road indicated be made one way (from 7 Stars to bridge) with signage/markings to make pedestrians and drivers aware that it is 'shared space'.**

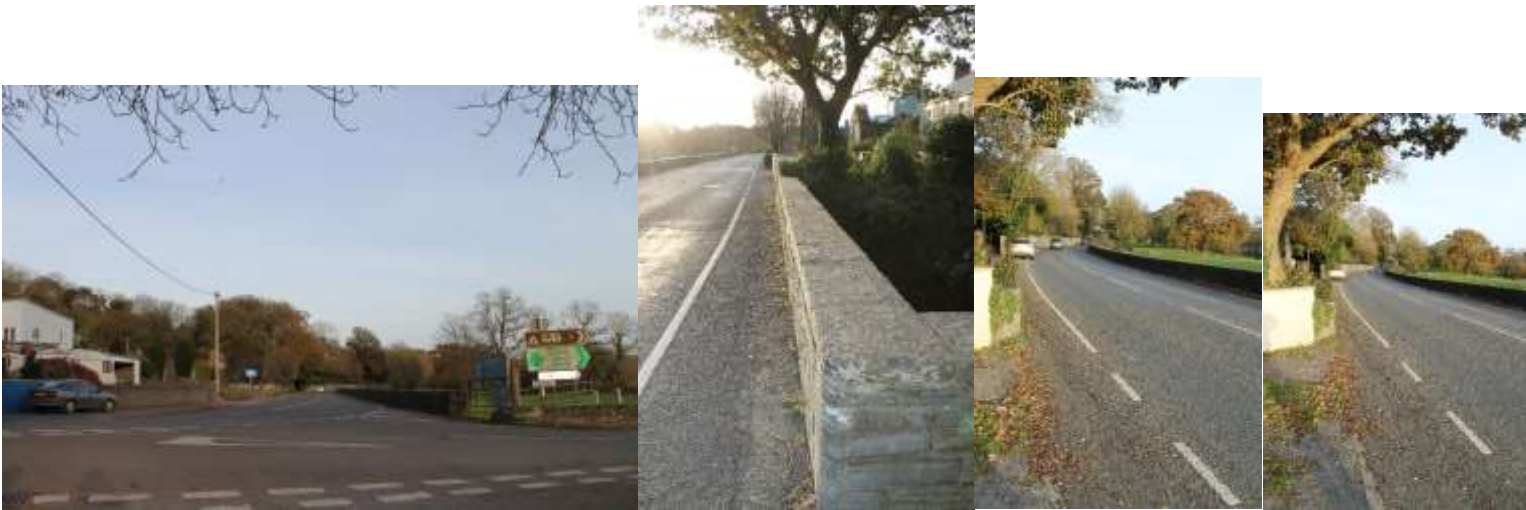
From the end of this road it is possible to cross onto footway opposite. This continues for a short distance until pedestrians have to proceed single file along the A484 and across the bridge (wider area or proper footway desirable here). There is then no footway or safely usable space from the beginning of the 'Glanarberth wall' to part way along as illustrated in the photographs.

**From the end of the above route it is possible to cross to a footway and continue along the A484 but the footway ends (as per the photographs) and pedestrians then have to walk along the A484 until the footway starts again part way along the Glanarberth wall. Again, the Community Council requests that Ceredigion County Council investigate if there is any way to make this walk safer.**
