# Safety Inspection Report

Annual Inspection

## Playground, Llechryd

24 March 2025

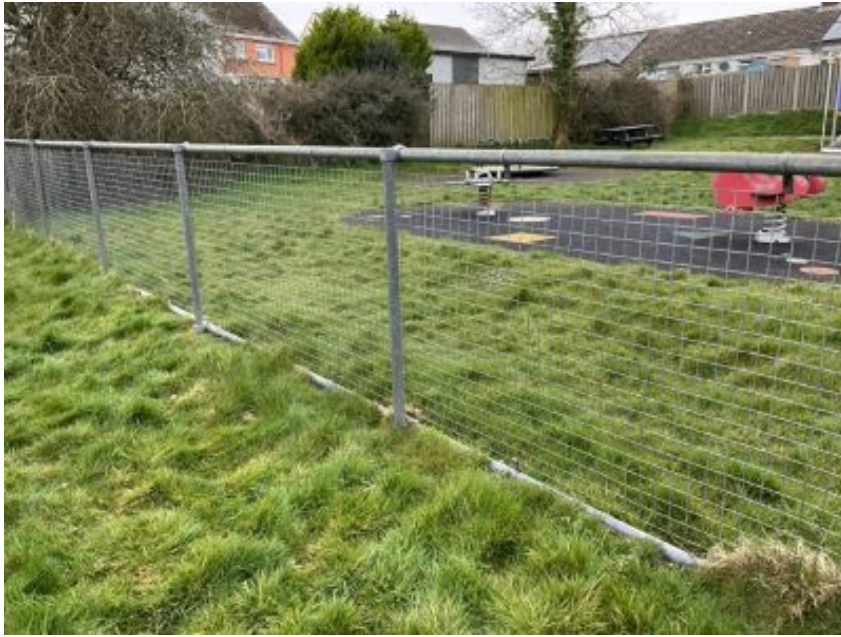
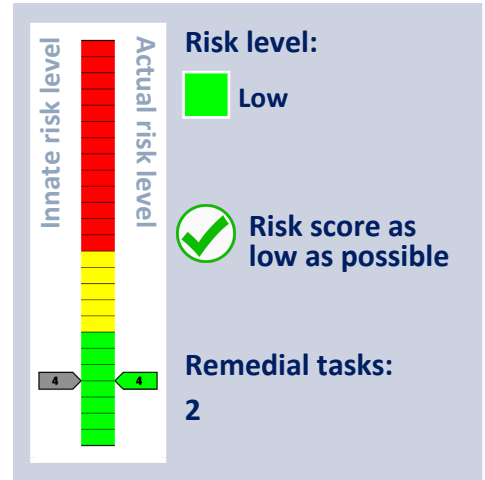
A1

Minor repairs are needed.

A section of the fence is missing.

## Repair.

Replace the missing parts.

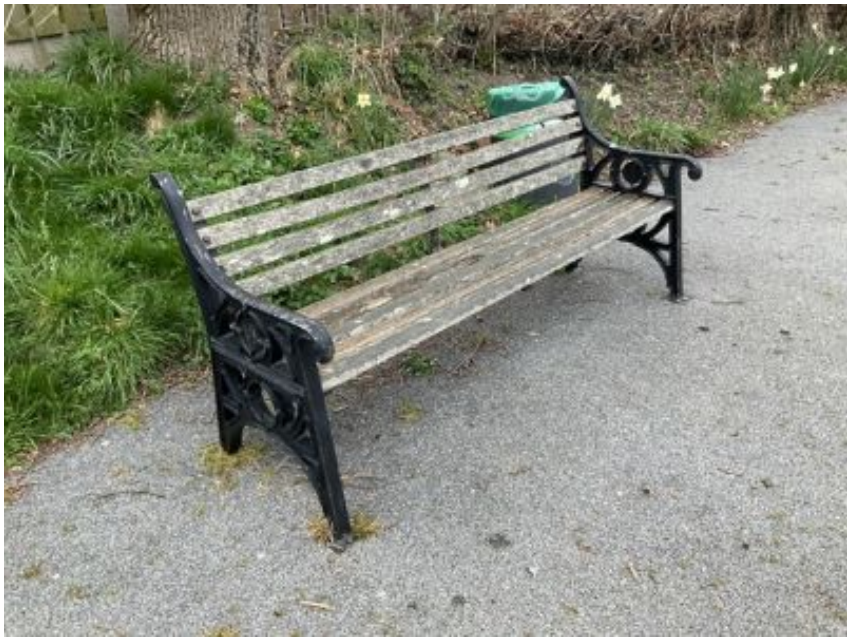
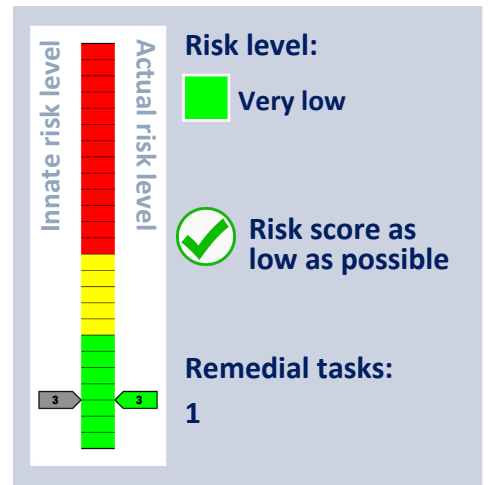
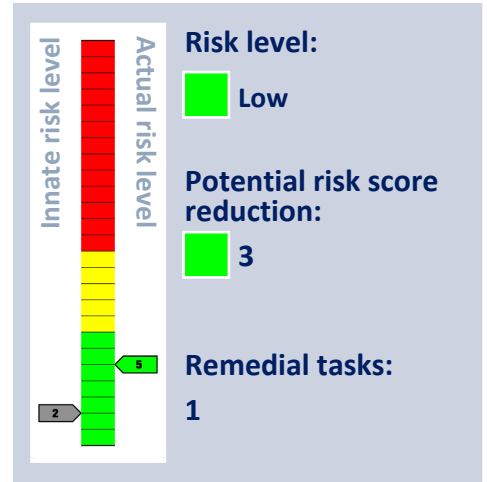
# Seating - Bench

Timber is decayed.

Fixtures loose or missing.

Replace affected parts.

Replace.

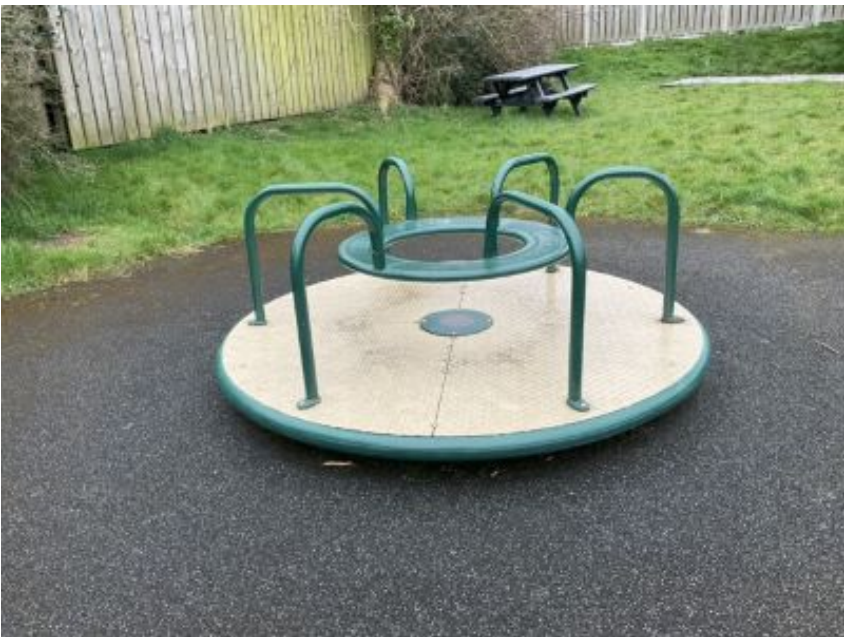
# Carousel

Shrinkage / separation of the surface. This may give a trip hazard.

Repair.

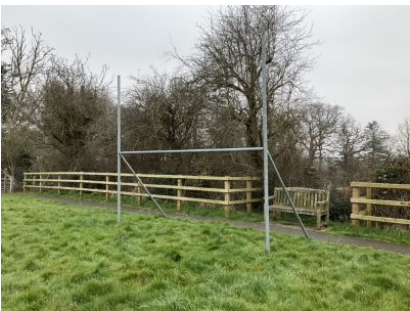
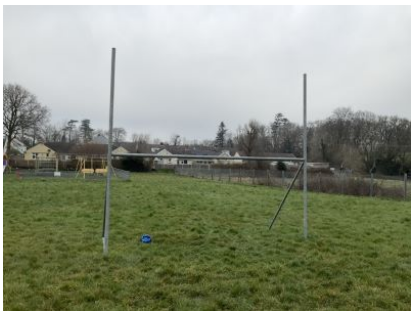
# Combination Goals/Rugby Posts

Additional comments are noted below.

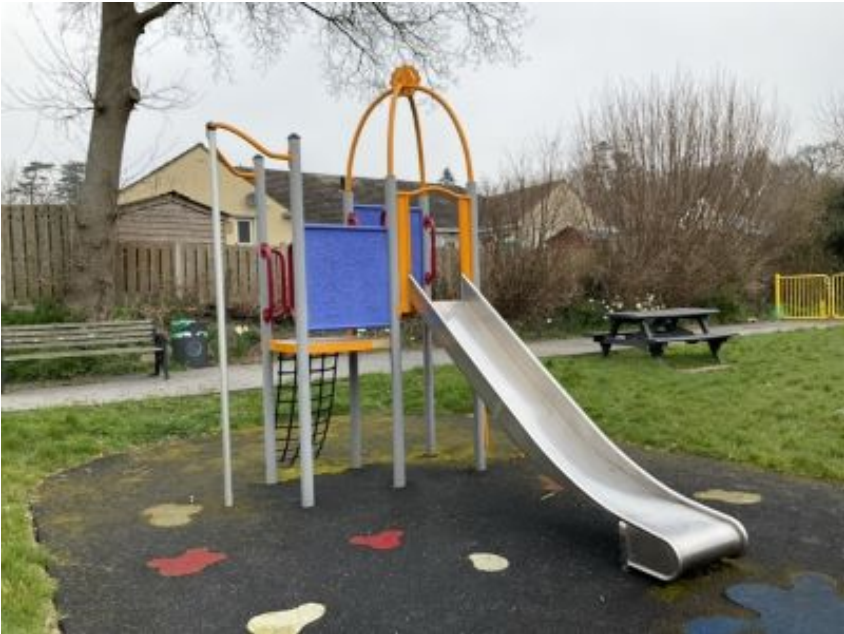
# Multiplay

Shrinkage / separation of the surface. This may give a trip hazard.

Item has corrosion.

Repair.

Treat and repair.

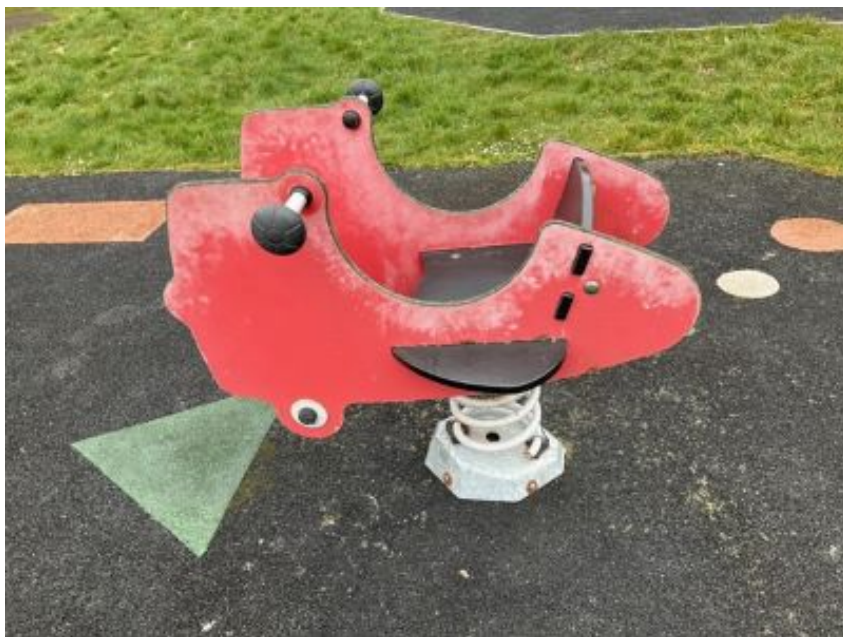
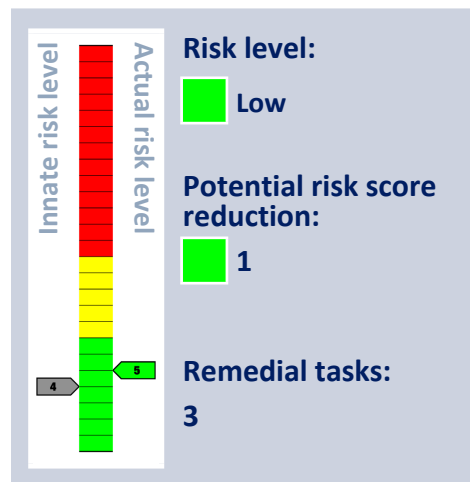
## Rocker - Plane

Item has corrosion.

Fixtures loose or missing.

Shrinkage / separation of the surface. This may give a trip hazard.

Treat and repair.

Tighten/replace.

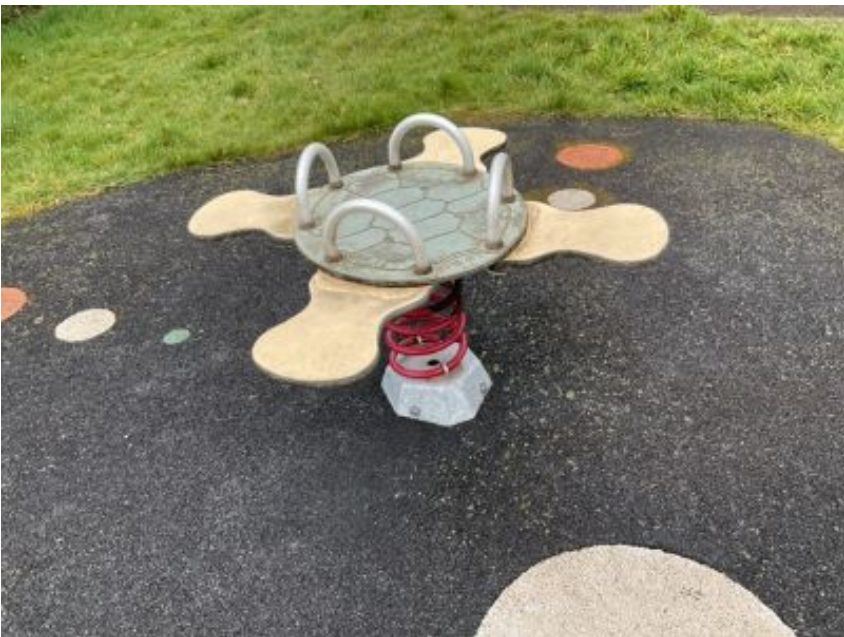
# Rocker - Turtle

Item has corrosion.

Shrinkage / separation of the surface. This may give a trip hazard.

Treat and repair.

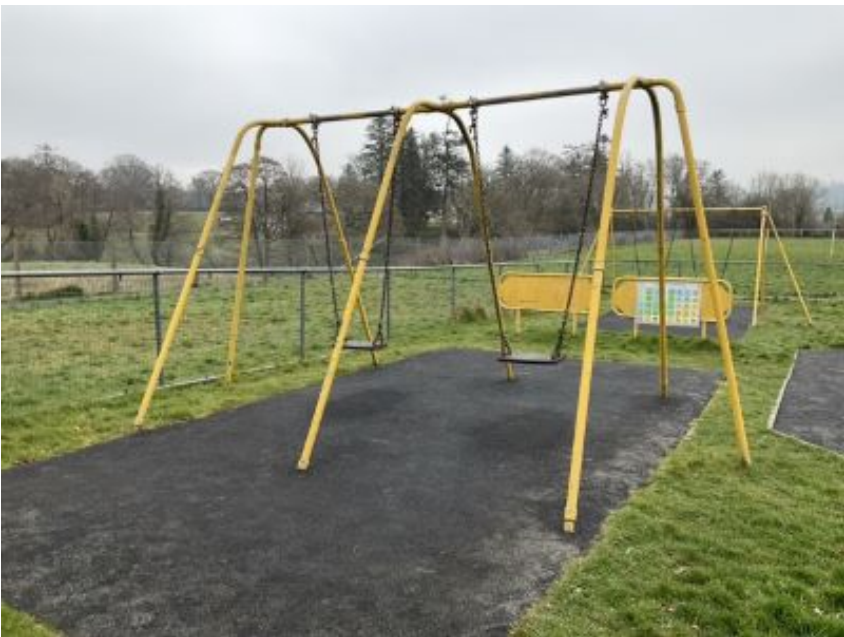
# Swing - Junior - 2 Bay 2 Seat

There is wear in the bushes.

Some chain wear.

Remove shackle bolt and check bush and shackle pin wear, replacing as necessary.

Monitor for further deterioration and replace before 40% wear.

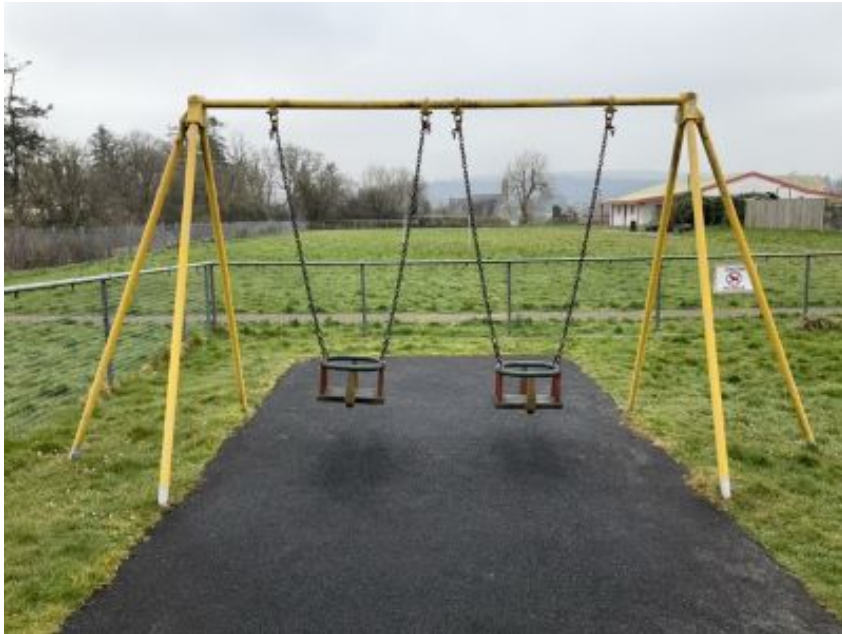
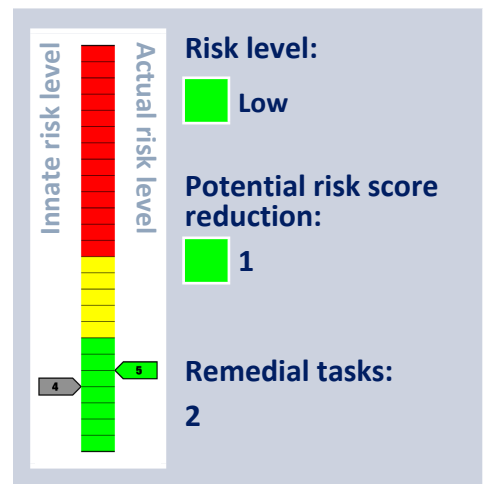
## Swing - Toddler - 1 Bay 2 Seat

There is wear in the bushes.

Item has corrosion.

Remove shackle bolt and check bush and shackle pin wear, replacing as necessary.

Treat and repair.

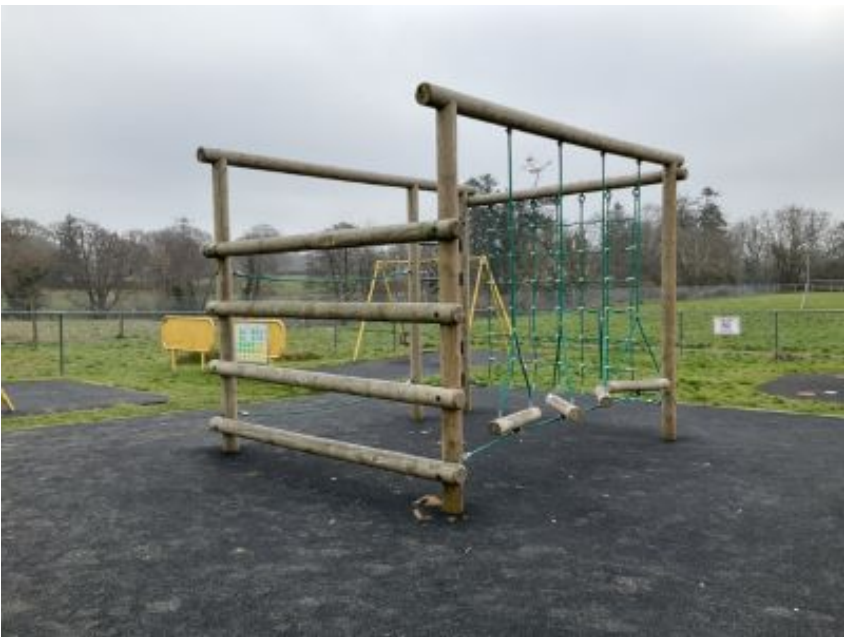
# Climber - Frame & Net

Loose in ground.
